Manhole Inspection Summary

Manhole # S17K__022MH

Insp Date: **7/1/09 9:33 AM**

Location Address: **S.Warwick Ave.**

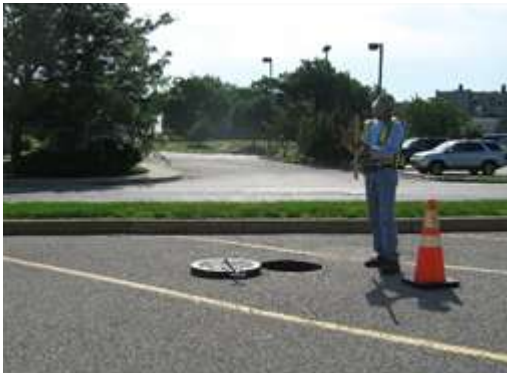
Location View

in Wendys parking lot

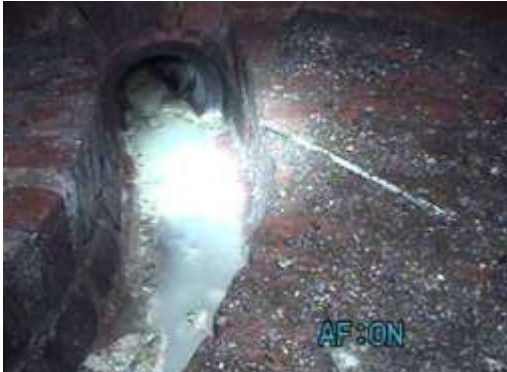
Misc.

Light debris (grease from Wendys)

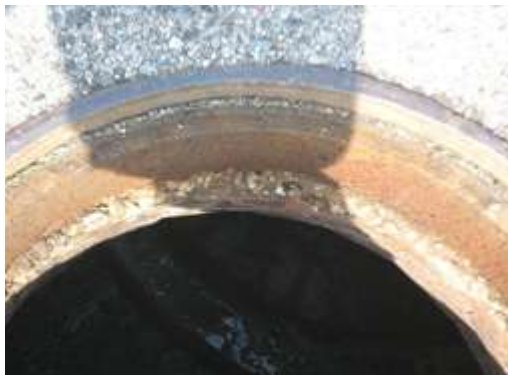
Defect 3

frame offset

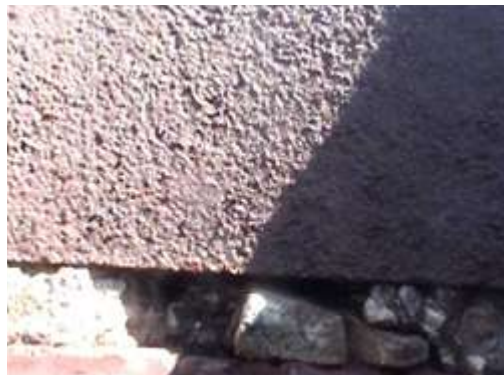
Defect 2

Condition: ☐ Sound ☐ Cracked ☐ Root Intrusion ☒ **Loose Brick** ☐ Deteriorated

missing mortar at chimney and frame joint

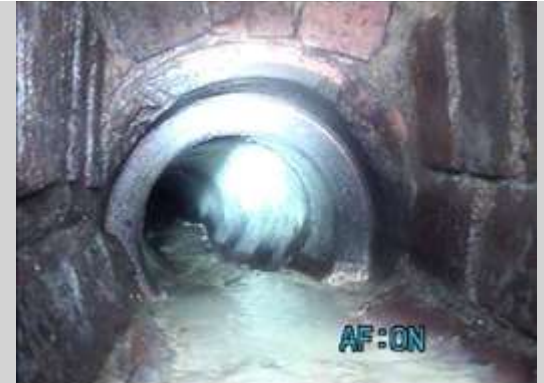
12 O'Clock Outflow

Pipe flows towards S17K__010MH,
but 010MH is actually a stormwater MH and
the downstream sewer connection
was not able to be determined.

Deposits: ☐ None ☐ Mud ☐ Sludge ☐ Debris ☒ **Grease**

Silt Depth: **0** (in.) Deposits Extent: **Light**

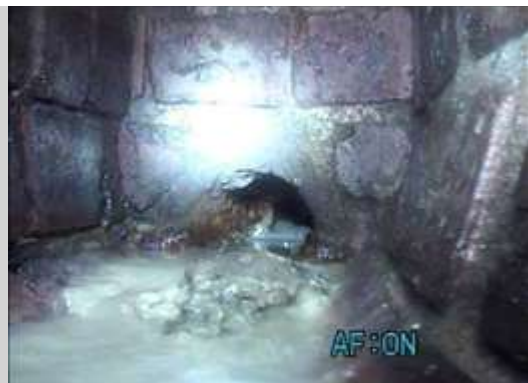
8 O'Clock Inflow

likely connected to S17K__018MH.

Deposits: ☐ None ☐ Mud ☐ Sludge ☐ Debris ☒ **Grease**

Silt Depth: **0** (in.) Deposits Extent: **Light**
